**MOTION FOR AUTHORITY TO USE CASH  
COLLATERAL TO REPLACE ROOFS AND FOR RELATED RELIEF**

**ROOF INVESTIGATION**

## Roofing & Siding Investigation

Cincinnati/Oaks of Prairie Point – Lake in the Hills, IL

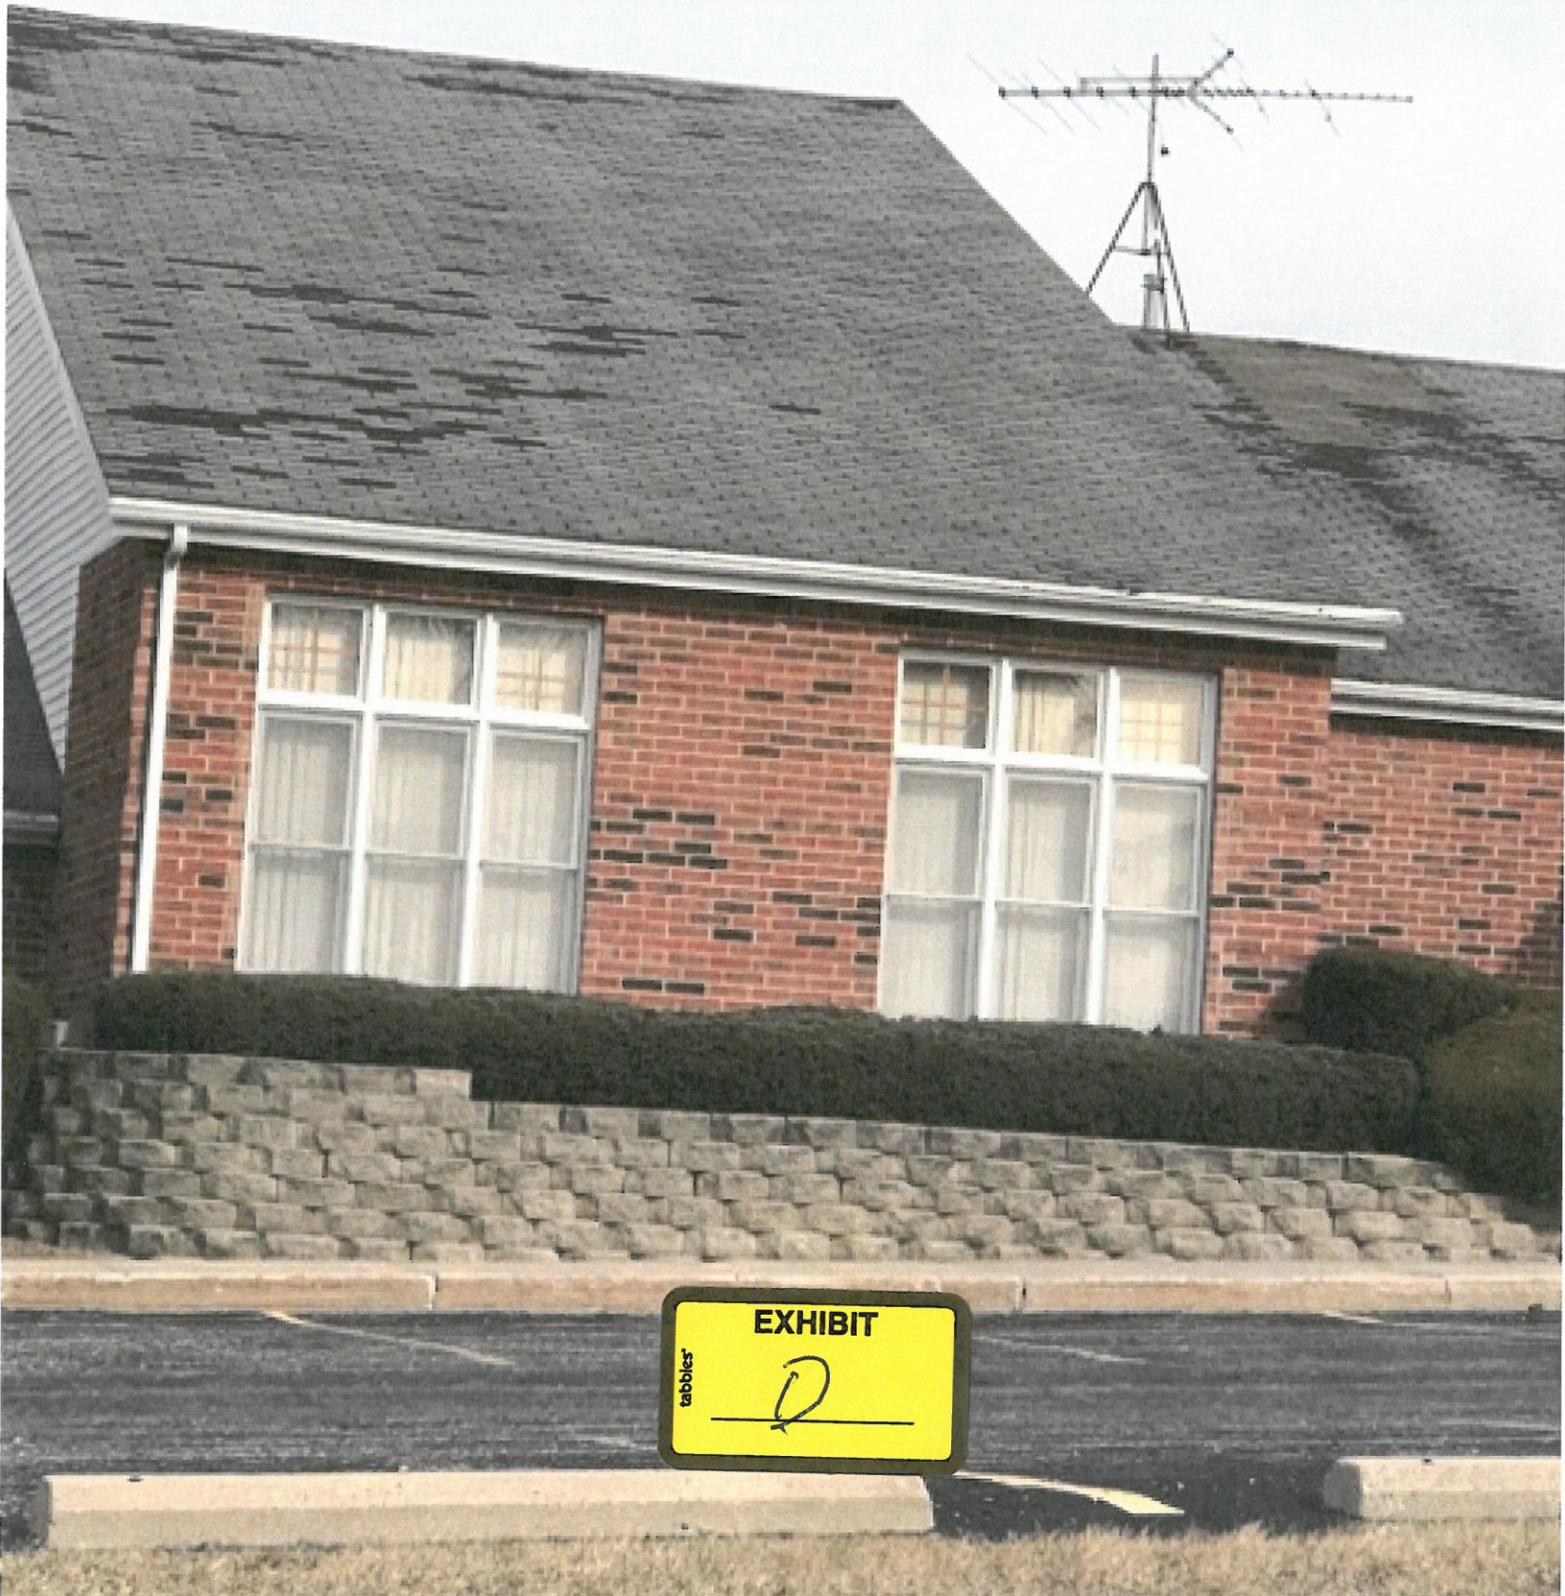
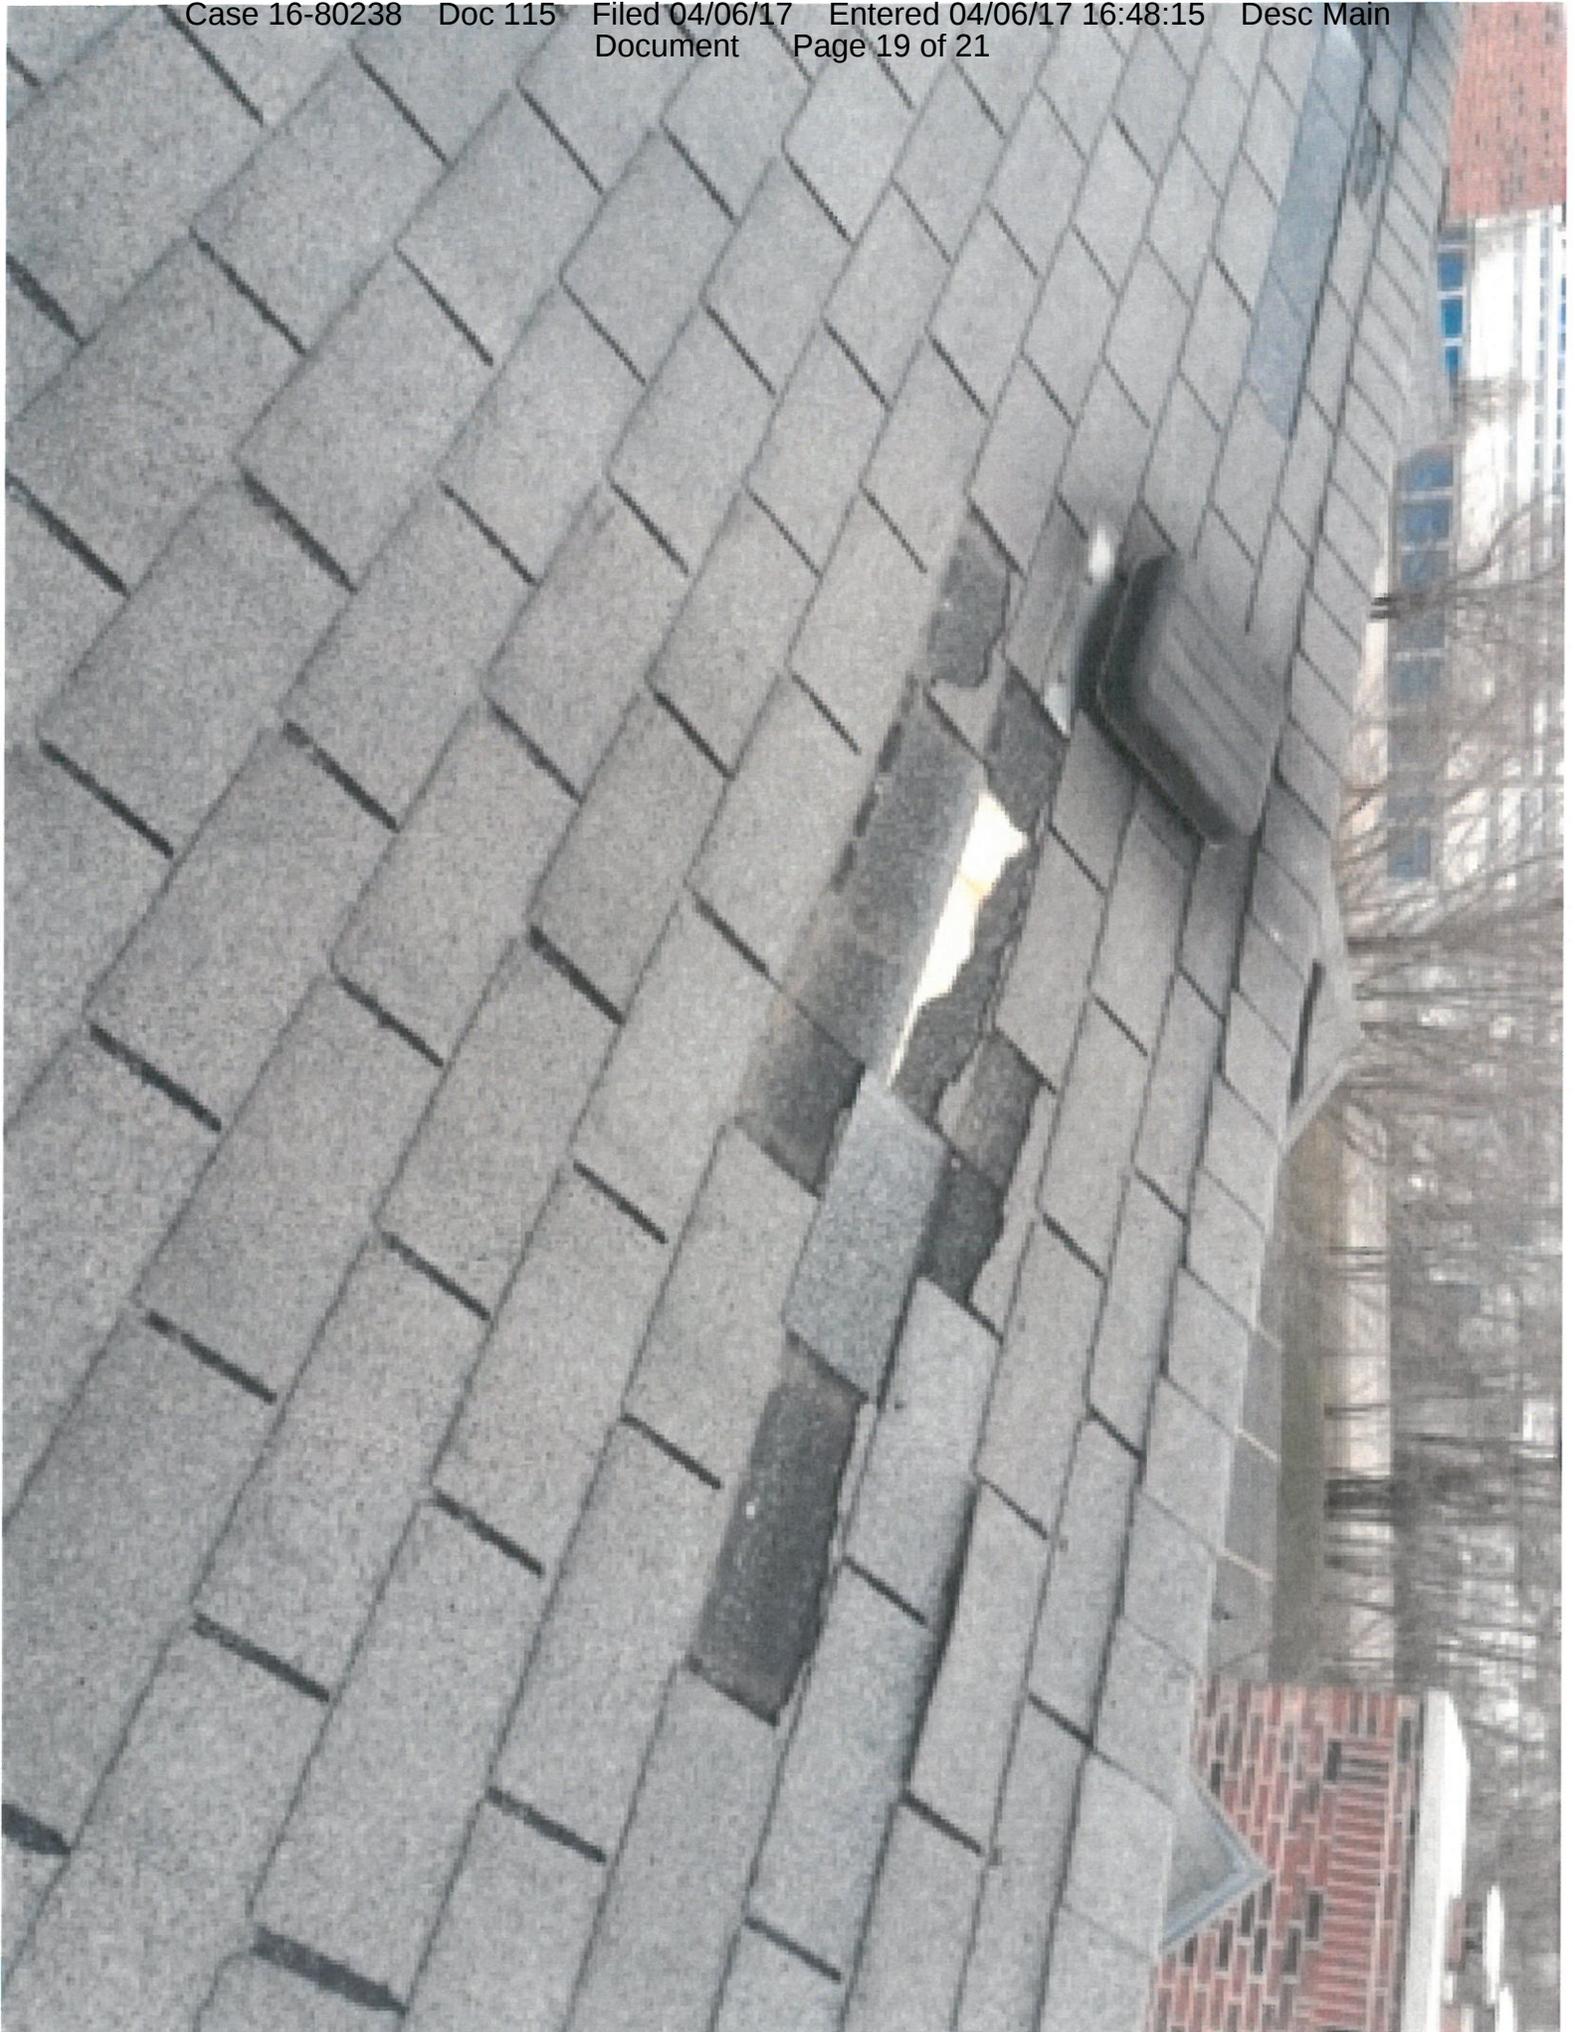
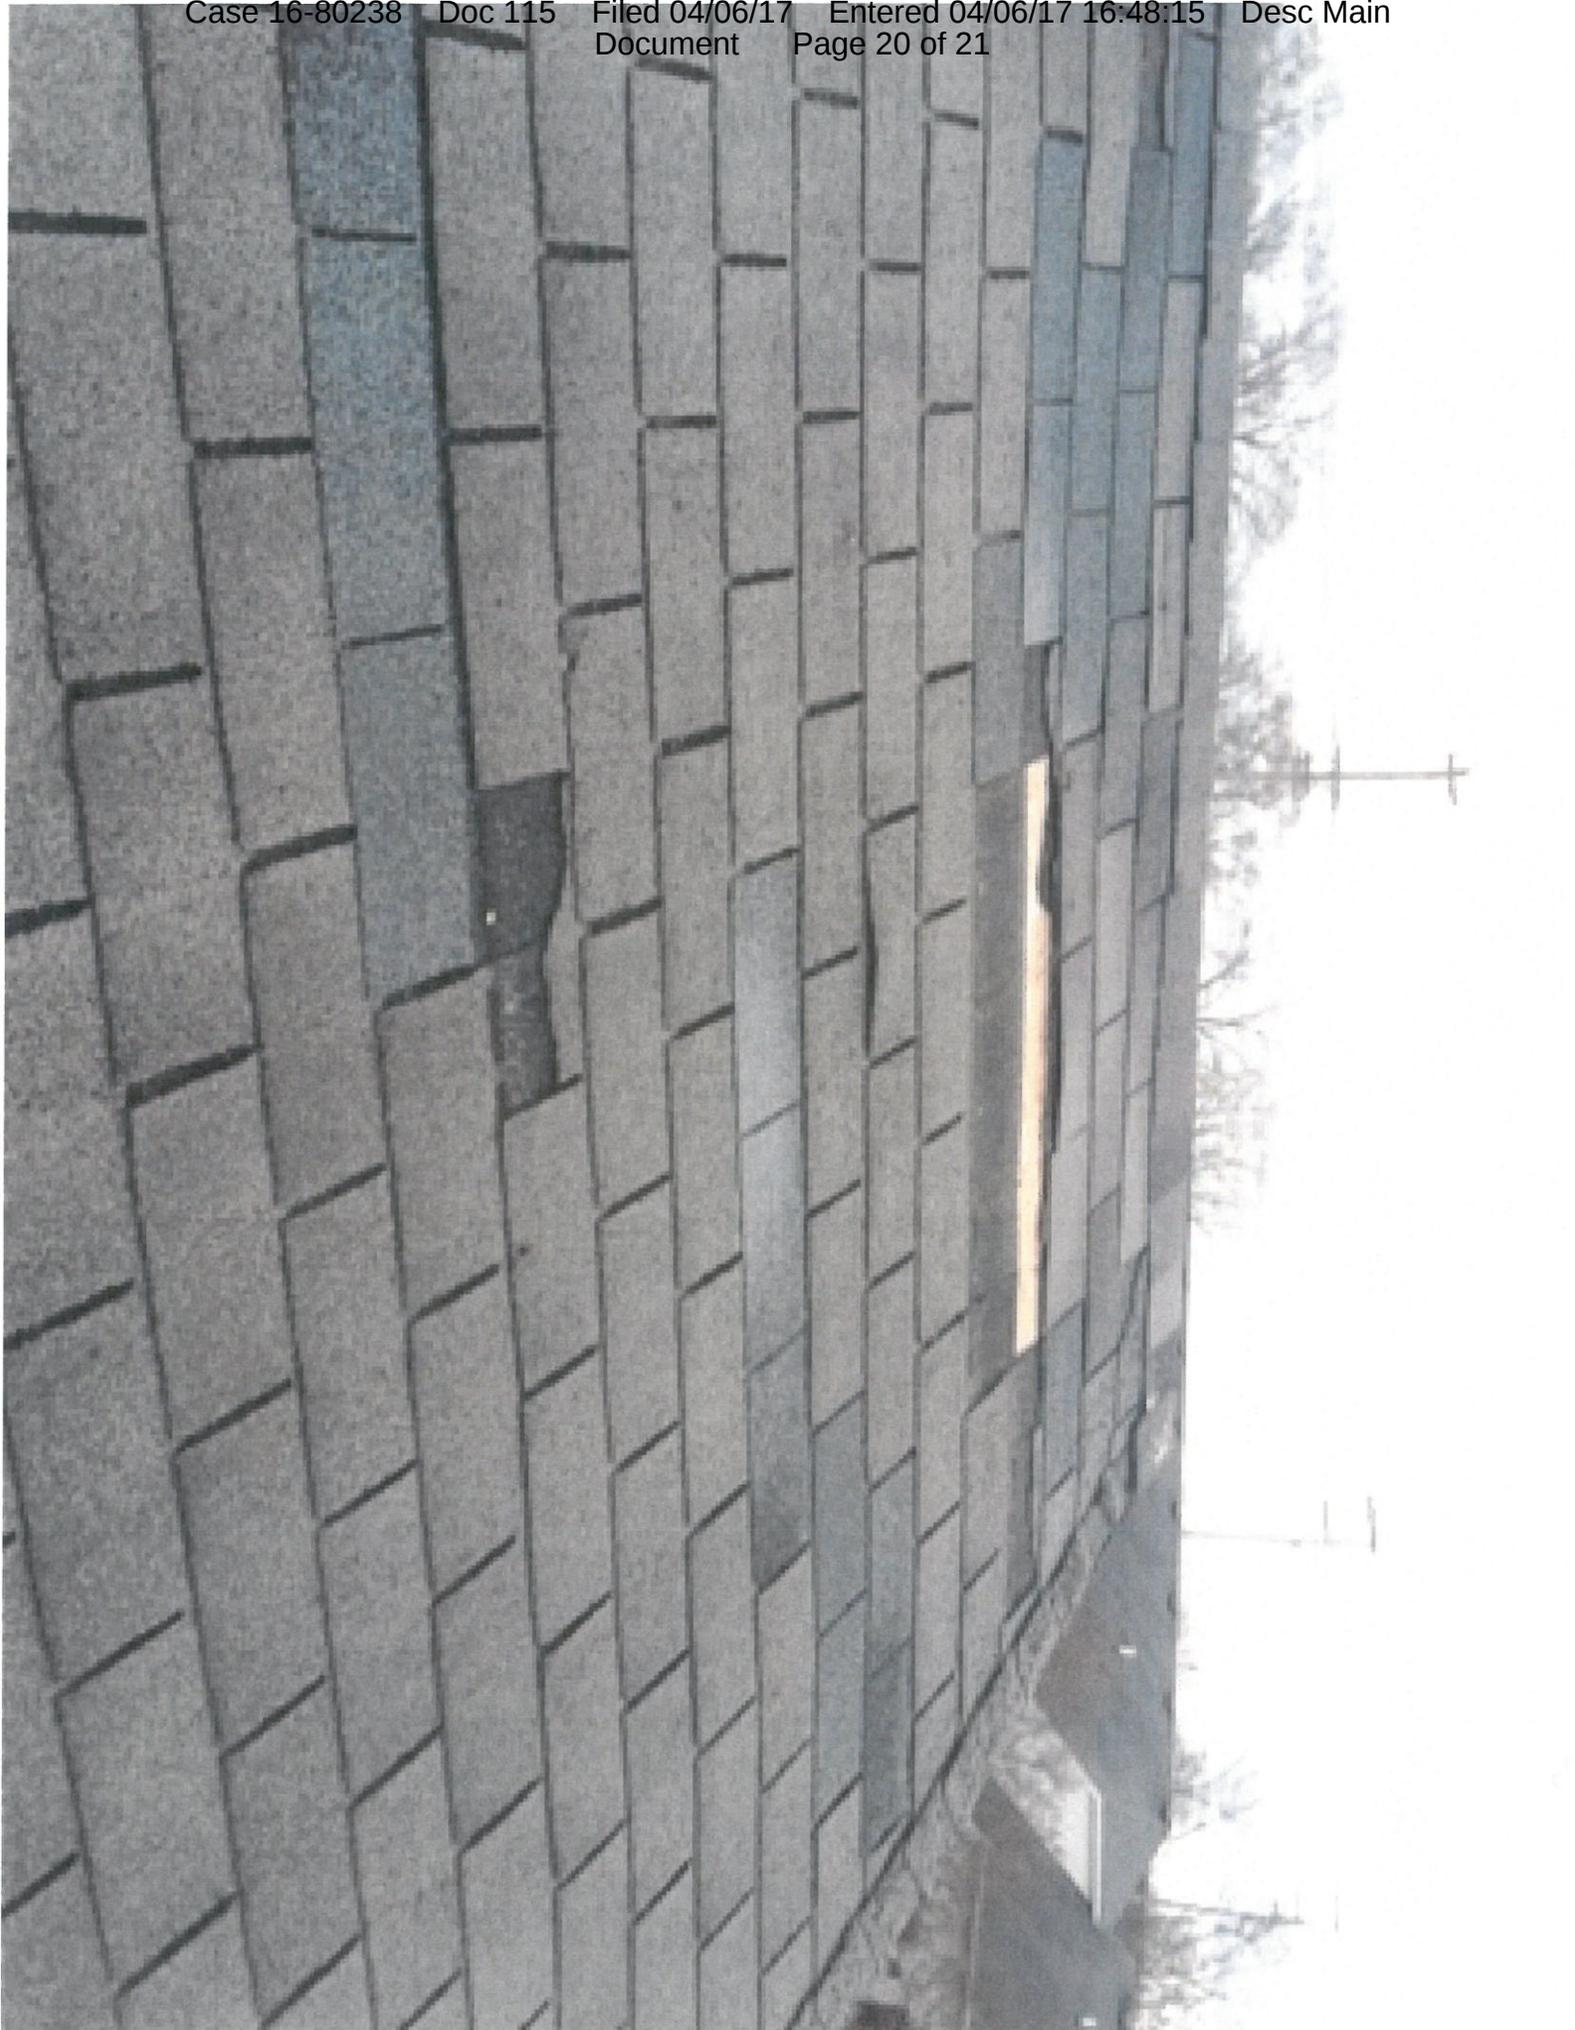
15. The Debtor has tried to do the minimum repairs but it has become apparent these repairs are both insufficient and a waste of money at this time. As set forth in the photographs attached as **Exhibit D**, the damage to the roofs and need to replace the roofs are obvious.

Patrick – as an fyi, we had a leak in the 1360 building. Hogan Roofing went. They replaced about 10 shingles that were missing and said there was minor damage in unit. The unit belongs to Marguerite Sutton, though, so there may be more damage.
